A Geomorphic Assessment of

Keyhole Site', Horsley Park, NS

Flow and Loam Environmental

Report prepared for: écologique

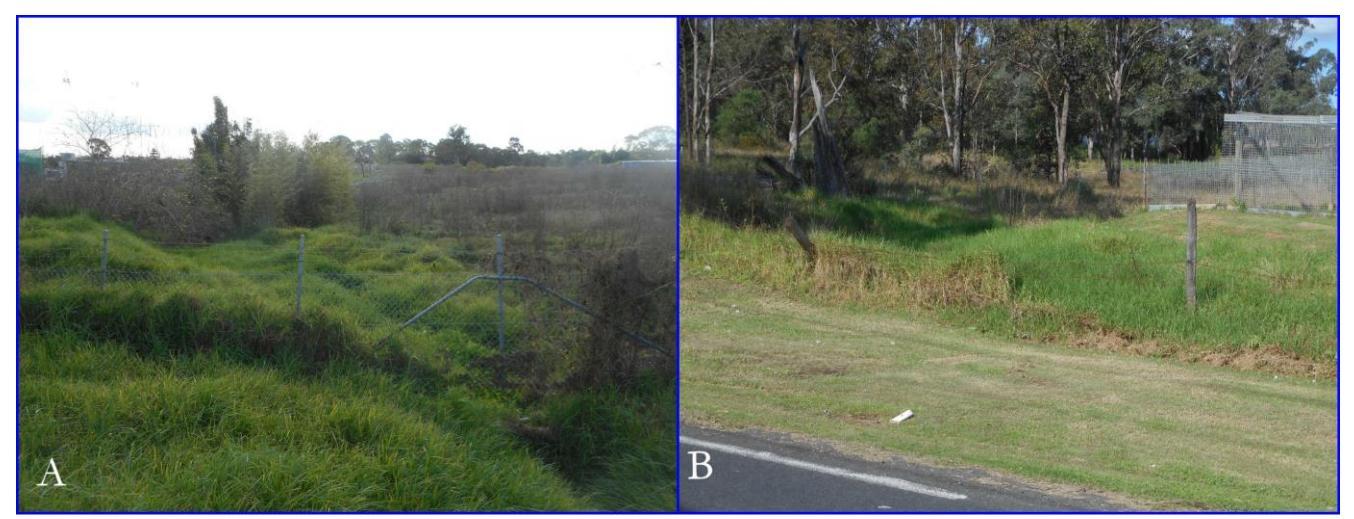
At site 21 there is a very low sinuosity drainage line extending downslope from the road. Upslope, the channel passes around what appears to be an infilled agricultural dam. At road side the channel has a very narrow base with low angle stable banks. The channel cross section is trapezoidal which indicates anthropogenic modification (Figure 3).

Down slope there is a macro channel with width increasing to greater than 12 m. The inset base flow channel is masked by vegetation.

Figure 3. Site 21. 'A' Looking down slope and 'B' Looking upslope

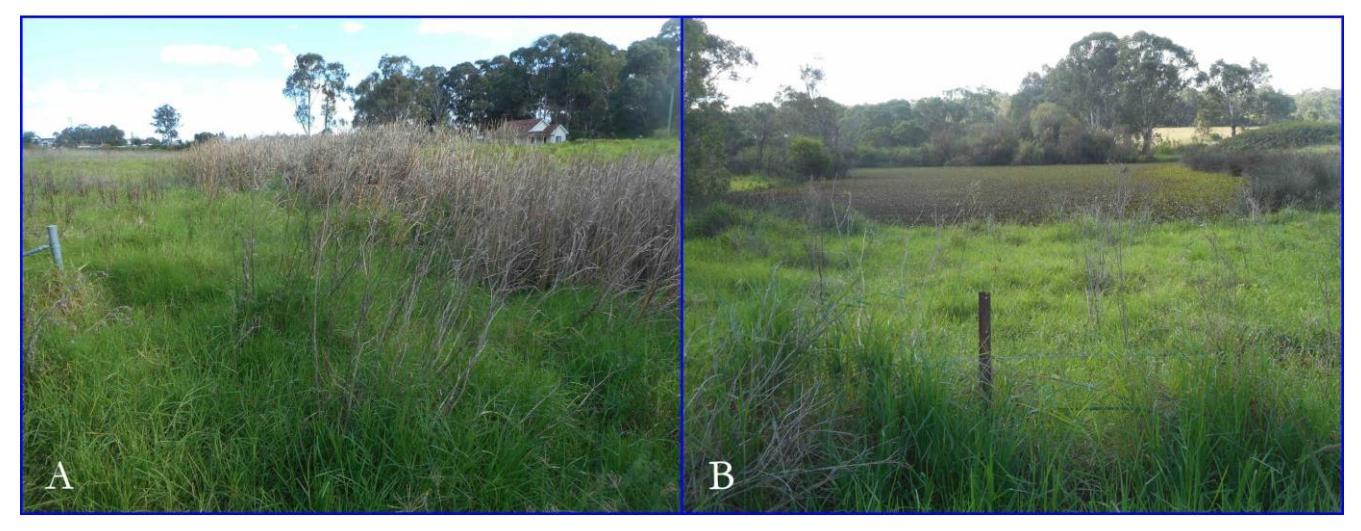
At site 22, downslope from the road, there is a minor flow path is less than 2 m wide and is completely obscured by weed infestation. The character of the channel cannot be determined. The flow path leads to weed choked dam down slope (Figure 4).

There is a similar morphology on upslope side of road where the drainage channel from an agricultural dam spillway is choked with rushes.

The upslope channel appears to be narrow, very low sinuosity, and anthropogenically modified.

Figure 4. Site 22. 'A' Looking upslope and 'B' looking downslope

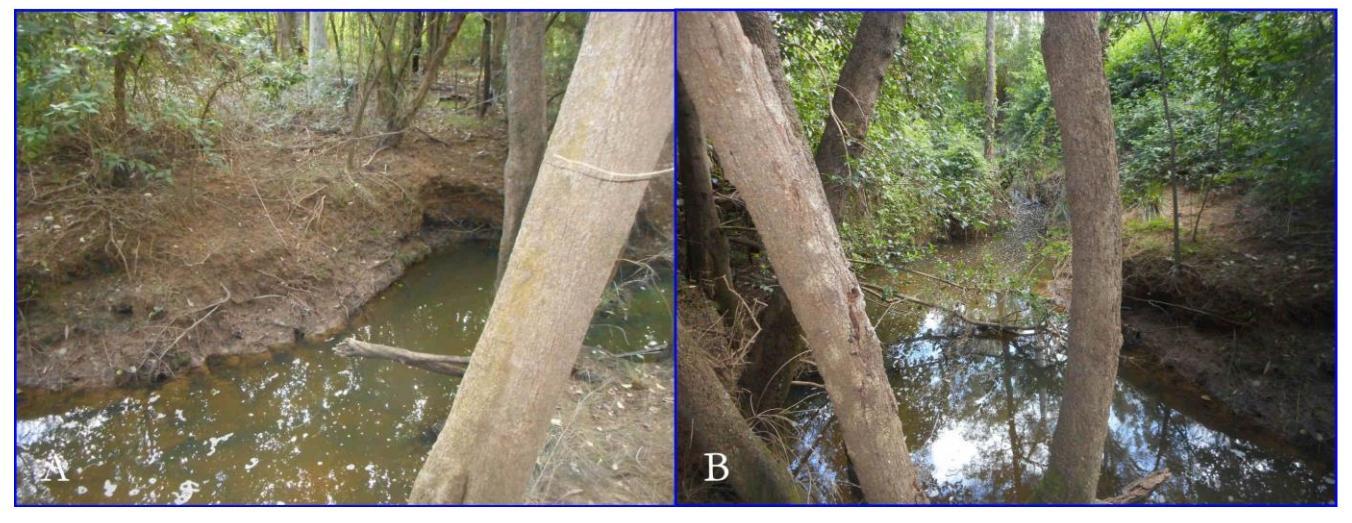
At site 17 Eastern Creek exists as an elongate pool – glide – riffle sequence (Figure 6). Elongated pools and glides are separated by steps in the longitudinal profile varying between 0.40 and 0.80 m. There are three profile steps within 40m of site 17 location. The water surface over the riffles is not broken.

There is a short length of, what may be, remnant floodplain inset within the low flow channel that has a scour feature around tree fall indicating an erosional environment.

Water depth is greater than 1.05 m in places and less than 0.10 m over riffles. The width of channel at water surface is variable from 0.40 m to a maximum of 3 m. The bank height is also variable to a maximum of 3.5 m. Channel width, bank top to bank top is 8 - 10 m.

Figure 6 Site 17 'A' Looking downstream and 'B' looking upstream

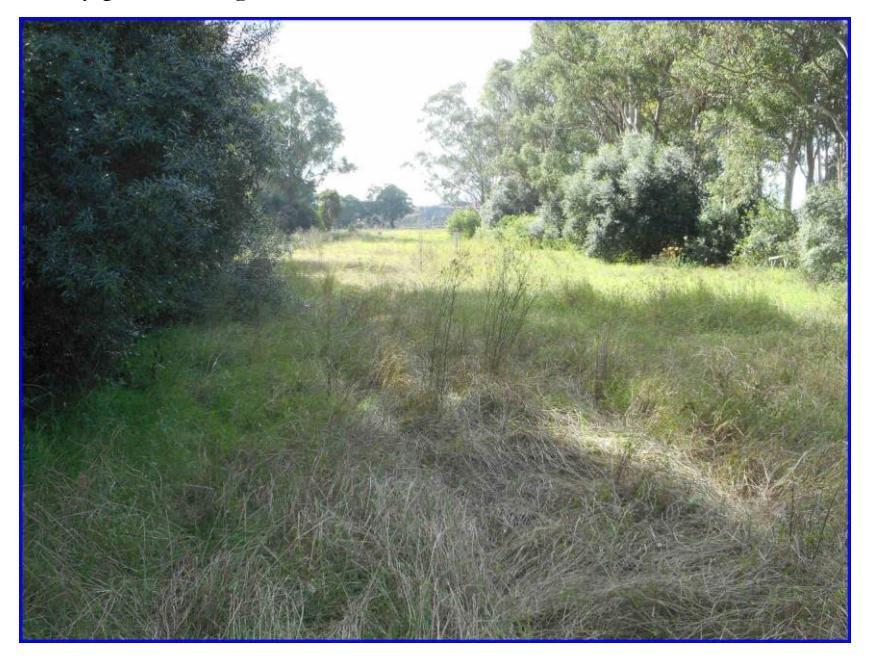
Often, where channels are realigned for some reason, the old pre-existing channel is filled in. However, over time, there is often faint surface morphology reflecting the position of the old channel as the fill settles.

An assessment of historical aerial photography may reveal a pre-existing channel here but there is no indication or evidence of any pre-existing channel.

Figure 7 Site 18 looking down slope to the location of the Hydroline meander bend.

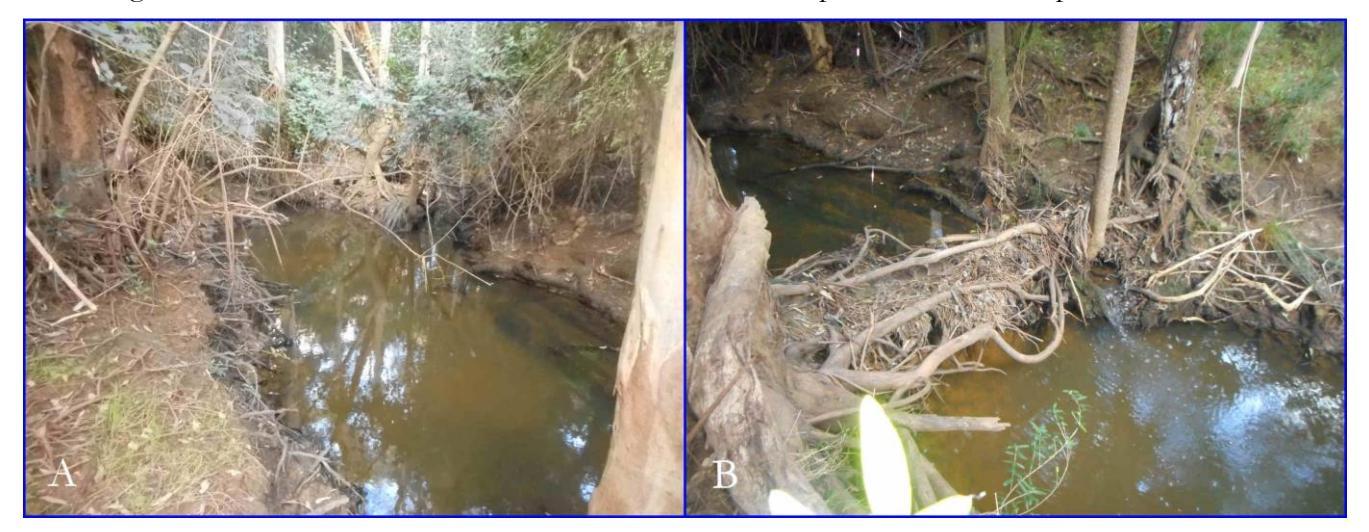
Site 19

Multi phase, sub-vertical banks extend to 3.5 m; the channel width at water level varies between 4 and 5 m and the channel width from bank top to bank top is variable between 7 and 9 m. The banks are erosional.

At proximal bank top, right bank, there are scour zones and litter dams in and around vegetation indicating recent overbank flows and that the channel is still coupled with the floodplain..

Figure 8. Site 19. 'A' looking upstream over a pool and 'B' showing a step in the longitudinal profile that has formed at roots crossing the channel

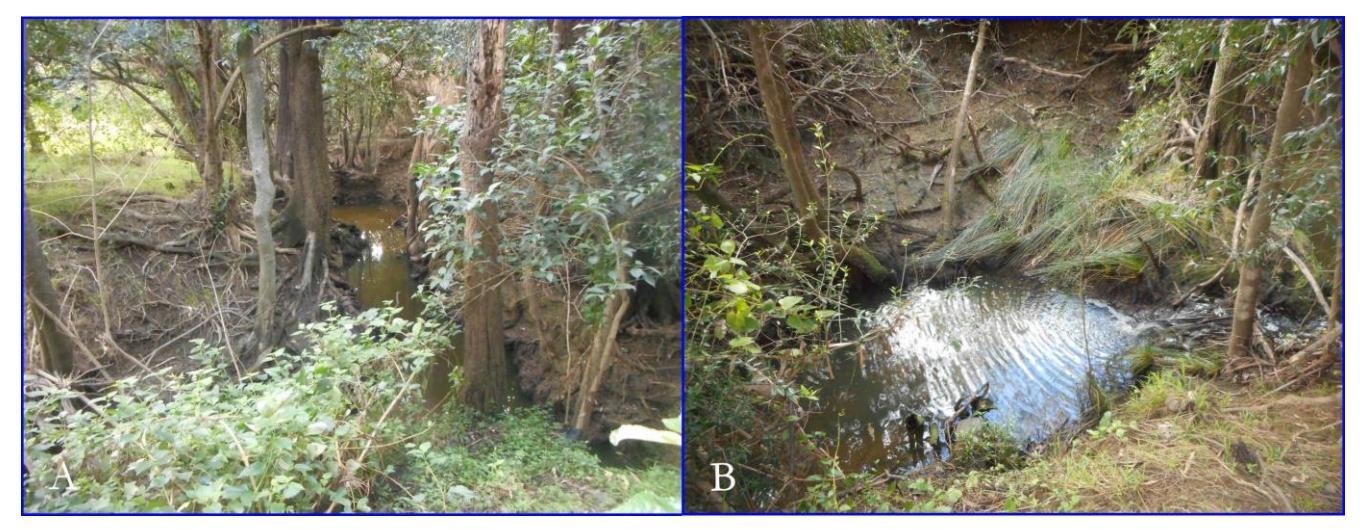
Site 20

There are scour zones proximal to right bank top indicating recent overbank flows.

There is opportunistic deposition of sediment in backwater of small tributary at left margin.

Figure 9. Site 20. 'A' Looking upstream over an elongate pool and 'B' Riffles over root dam in base of channel

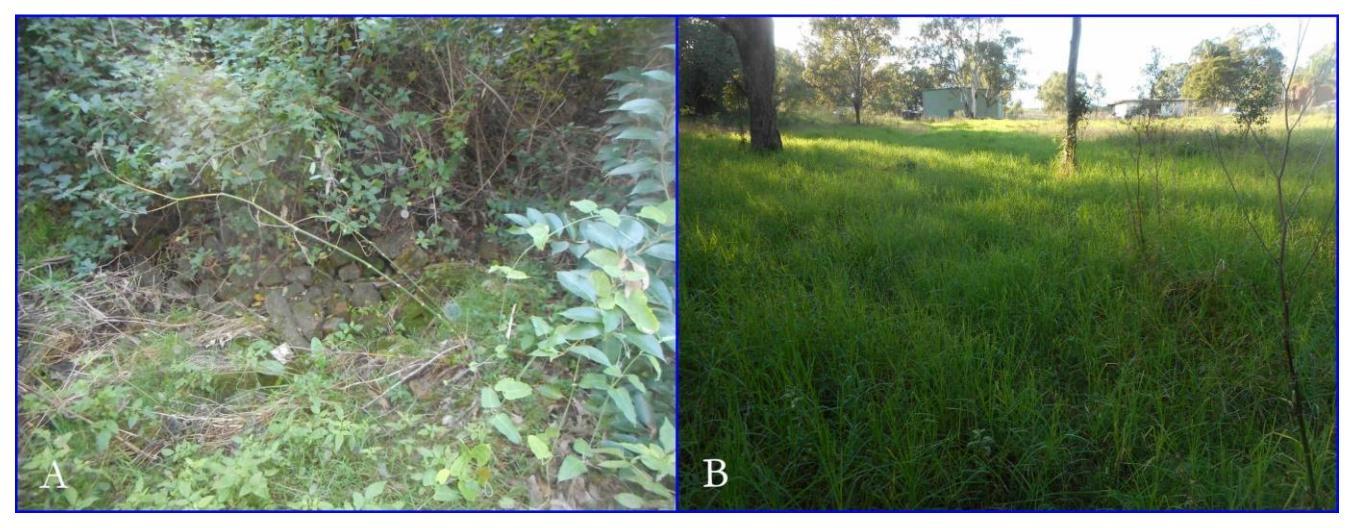
There is a short length of channel between site 5 and the upper boundary of the study area that has remnant chain of ponds morphology with a continuous channel. The channel ends at the boundary between Lots 73B and 81B which is also the boundary of the study area. At this location the defined channel and has been stabilised by rock fill (Figure 11A). Site 2 is located outside of the study area upslope on an area where there is no defined channel (Figure 11B).

The low flow channel through this reach is well defined with low angled and well vegetated banks. At some locations the banks appear to be two stage which may indicate the passage of a knickpoint through this reach.

Figure 11. 'A' shows knickpoint stabilised by rock fill. Defined channel ends here. 'B' is looking up slope from Site 2; no defined channel

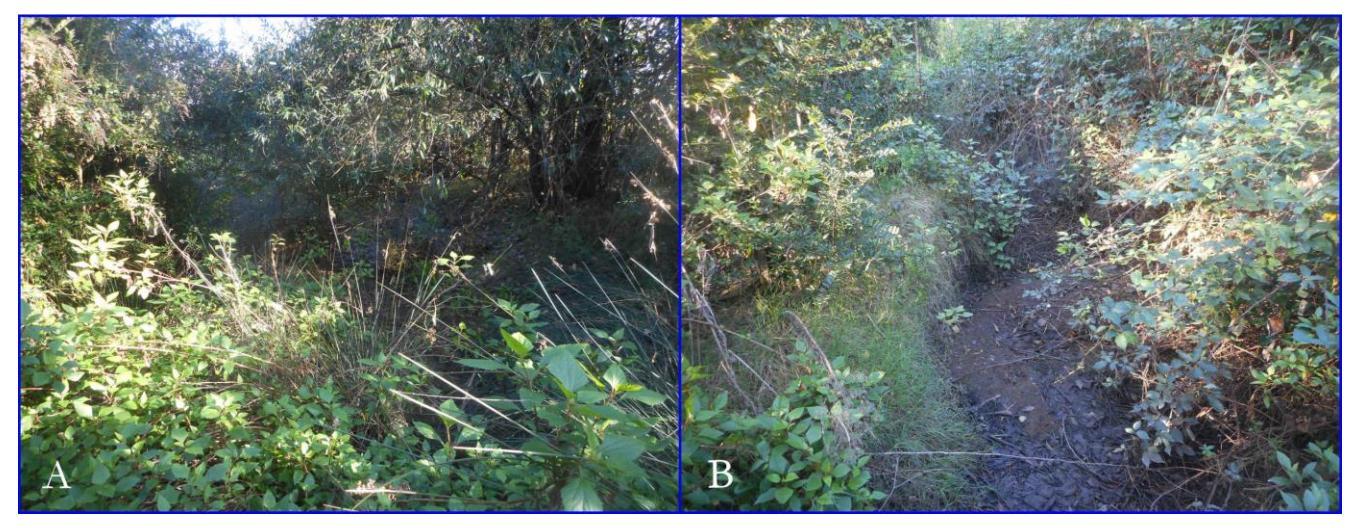
There is also some remnant pond morphology at site 3 where the channel widens out from 2 metres in width to more than 8 metres. The stagnant water that was evident at site 1 is not in evidence here. The channel and pond base has been dry for an extended period.

Sediment spear testing at sites 3 and 4 penetrates easily, with very little resistance to 1.05 m. There is a narrow, sub-horizontal, floodplain pocket at bank top left bank that has sediment over saprolite to 0.40 m as indicated by sediment spear testing.

Figure 12. 'A' looking upstream along the tributary towards site 4 and 'B' the tributary joining from left margin with recent deposition in the base of the channel

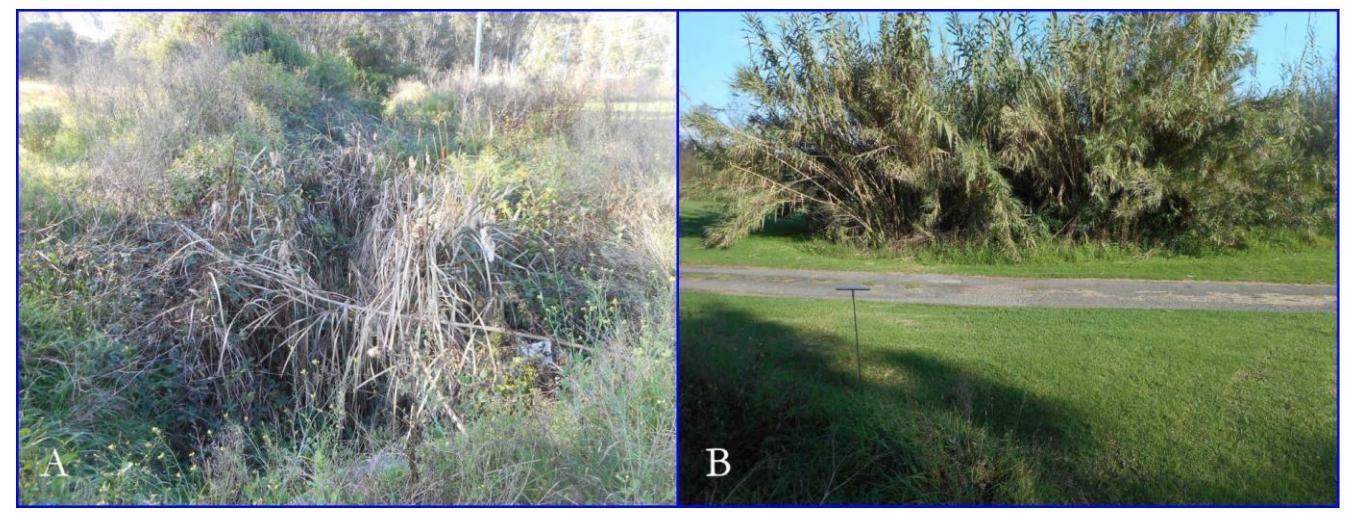
There is a suspiciously straight channel extending upslope of crossing. A straight channel in this environment indicates anthropogenically modified channel or an artificial channel. Sub-vertical banks to 3 m high are vegetated and stable. The channel width, bank top to bank top, is between 5 and 6 m.

Access to the channel zone downstream of site 6 is extremely difficult and limited by abundant and dense weed growth, notably blackberry. Site 8 is located on an old dam wall and is looking upstream.

Figure 13 'A' looking upstream from site 6. 'B' looking downstream from site 6. In both instances the channel is straight and choked with weed infestation.

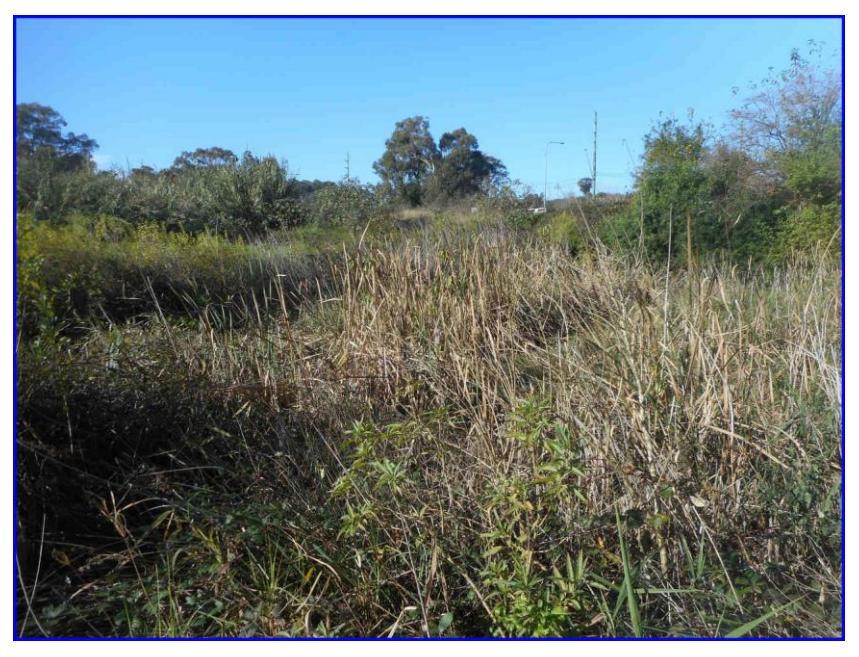
Figure 14 Site 8 looking upstream across the impoundment of the old agricultural dam that is now choked with weeds.

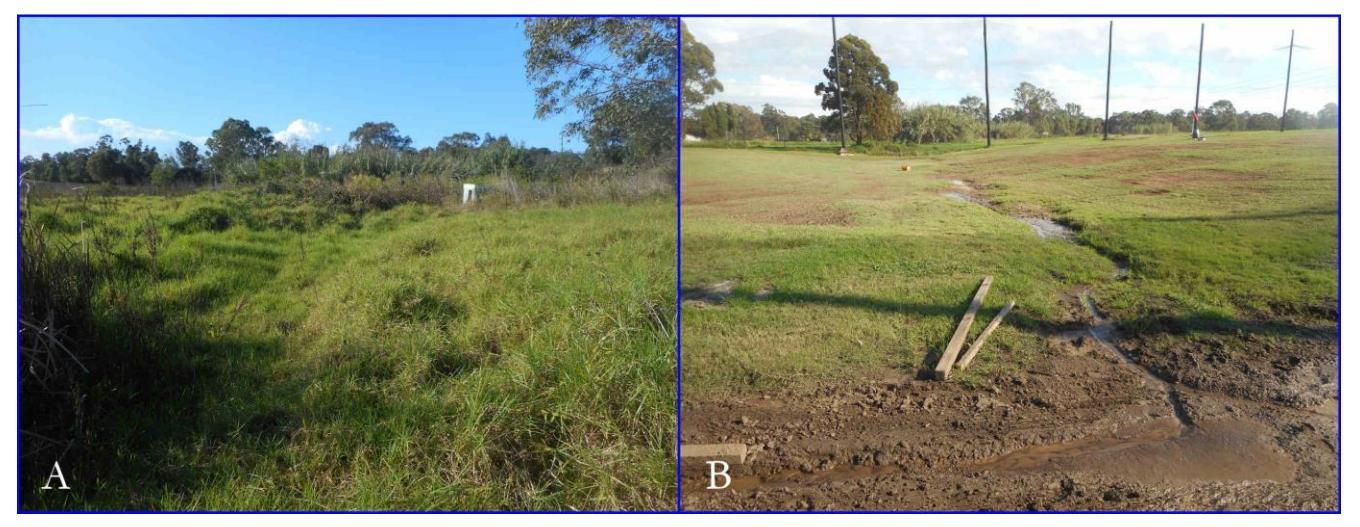
The upstream intake of the pipe is located between site 8 and site 9 but this area is completely overgrown and the exact location was unable to be determined. Most flows are diverted underneath the driving range through a subterranean pipe. There is a surface inlet grid at site 10 and at site 11. The end of the piped section is between sites 11 and 12 but is obscured by vegetation.

There is a surface low flow channel that has a low to moderate sinuosity with remnant ponds morphology. The low flow channel has a low capacity and discontinuous banks to 0.30 m. Flows that are unable to be contained within the pipe flow across the surface of the golf range. Interrogation of the historic aerial photography for 1978 (Appendix 3) show an agricultural dam at this location.

Figure 15. Location is site 9 at golf range boundary. 'A' is looking upstream to site 8 and 'B' is looking downstream to site 10.

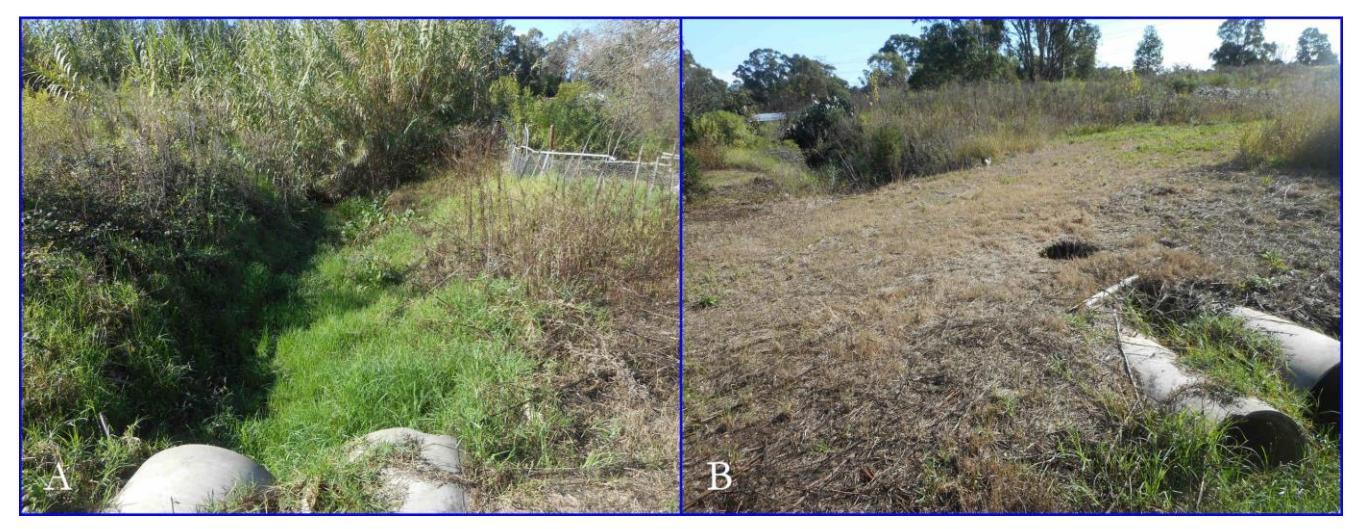
There is a very low sinuosity channel that shows evidence of anthropogenic realignment. Most of this reach was unable to be viewed and was largely inaccessible due to the abundant growth of blackberry, and other weed, obscuring the channel.

Figure 16. Site 13. Artificially straightened channel extending upstream 'A' and downstream 'B'

Further channel straightening and piping has occurred at sites 13 and 6. The channel has a very low sinuosity and is generally in a very poor condition.

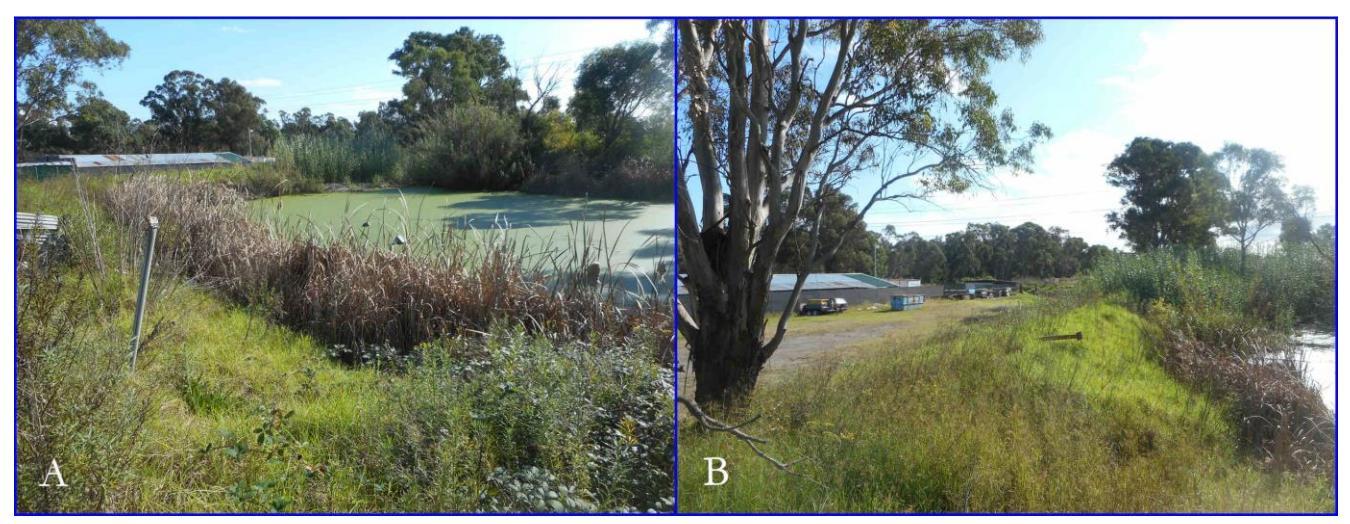
Sites 14 – 16

Agricultural dam (Figure 17). The channel ends where it flows into the dam at site 15. Site 16 is at the dam wall at property boundary.

Figure 17. 'A' Looking downstream from site 15 across the dam and 'B' is looking across the dam wall to a highly modified zone of degraded channel
