2025/26-2034/35 ASSET MANAGEMENT PLAN COMMUNITY BUILDINGS

INTEGRATED PLANNING AND
REPORTING FRAMEWORK

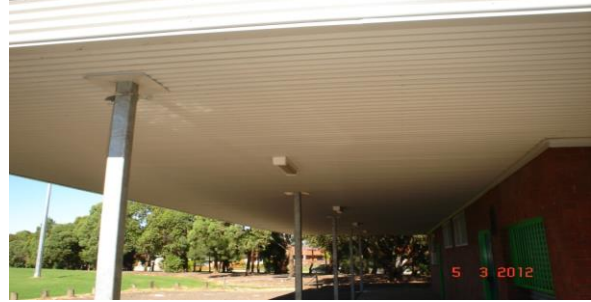
Roof

Condition 1: No work required (normal maintenance)

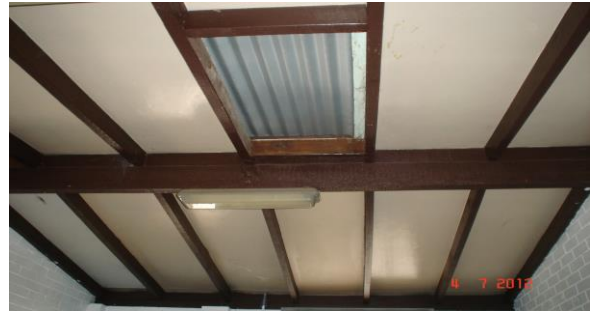
Roof

Condition 2: Only minor work required

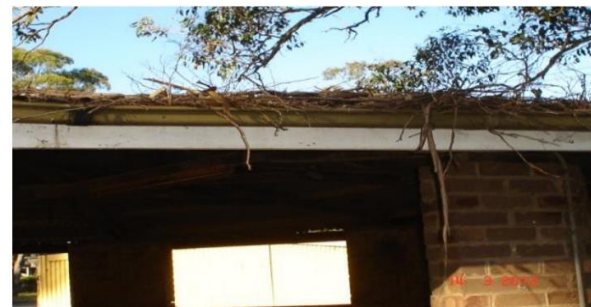
Roof

Condition 3: Some work required

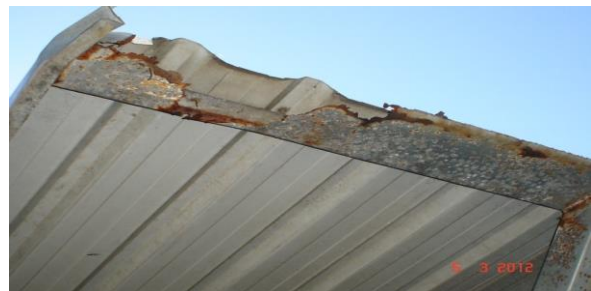
Roof

Condition 4: Some renovation needed within 1 year.

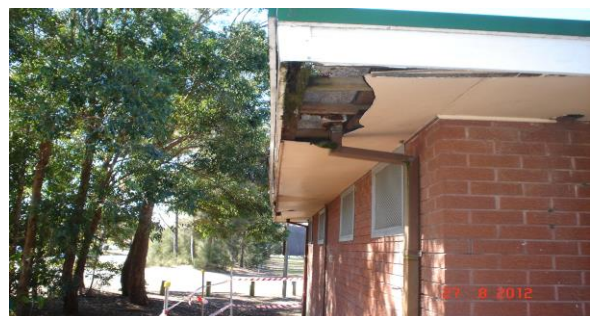
Roof

Condition 5: Urgent renovation/upgrading required.
