A Geomorphic Assessment of

Keyhole Site', Horsley Park, NS

Flow and Loam Environmental

Report prepared for: écologique

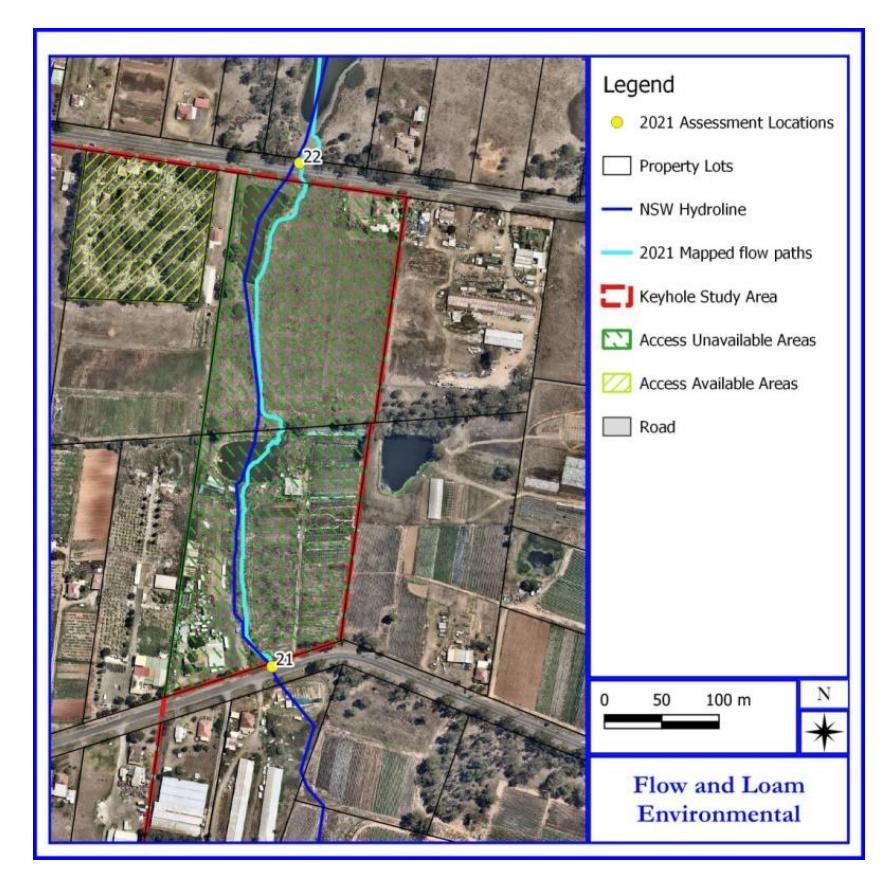
Figure 2. Study Area 1

Desktop interpretation of contemporary aerial photography and DEM indicates that the reach between Chandos Road and Redmayne Road consists mainly of two agricultural dams, their associated spillways and connecting drainage pathways.

Within Area 1 the low gradient and fine grained substrate would normally define a reach of moderate to high sinuosity but the sinuosity here is very low at 1.03 for the Hydroline and 1.13 for the contemporary mapped flow paths.

An existing flow path can be identified from the aerial photographs but it is masked by dense growth of vegetation and its character cannot be determined by aerial photograph interpretation alone. With a very low sinuosity these channels are probably artificial and are essentially agricultural drains.

There was no access for site assessment in lots 54 and 63 and therefore site inspection was limited to what could be viewed from the adjacent roadways. Inspection sites for area 1 are sites 21 and 22 (Figure 2).

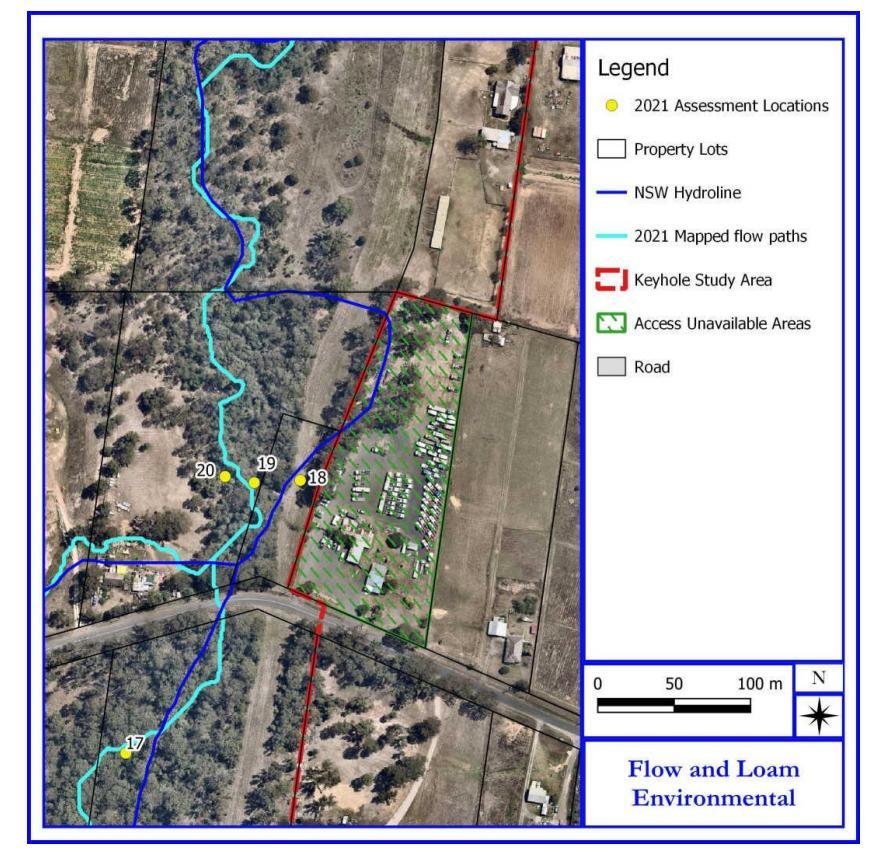
Figure 5. Study Area 2

During desktop assessment there was no evidence found of a channel as at this location extending into Lot 59B. Mapping of the contemporary channel line indicates Eastern Creek as a well defined channel to the west.

An assessment of channel sinuosity for Eastern Creek between Chandos Road and Redmayne Road was completed. The sinuosity of the Hydroline is 1.46 and the sinuosity of the 2021 mapped line is 1.37. The sinuosity for the Hydroline is artificially increased by the meander bend that has been mapped as extending into Lot 59B. This degree of sinuosity indicates a low level of anthropogenic channel modification. Ignoring channel incision processes as a function of changes in catchment hydraulics.

To confirm the presence, or absence, of a meander bend of Eastern Creek extending into Lot 59B a transect of three sites were assessed across the channel zone and these are sites 18, 19 and 20 (Figure 5). As a check on the morphology and character of the Eastern Creek, as mapped for this study, an additional site, site 17, was assessed upstream.

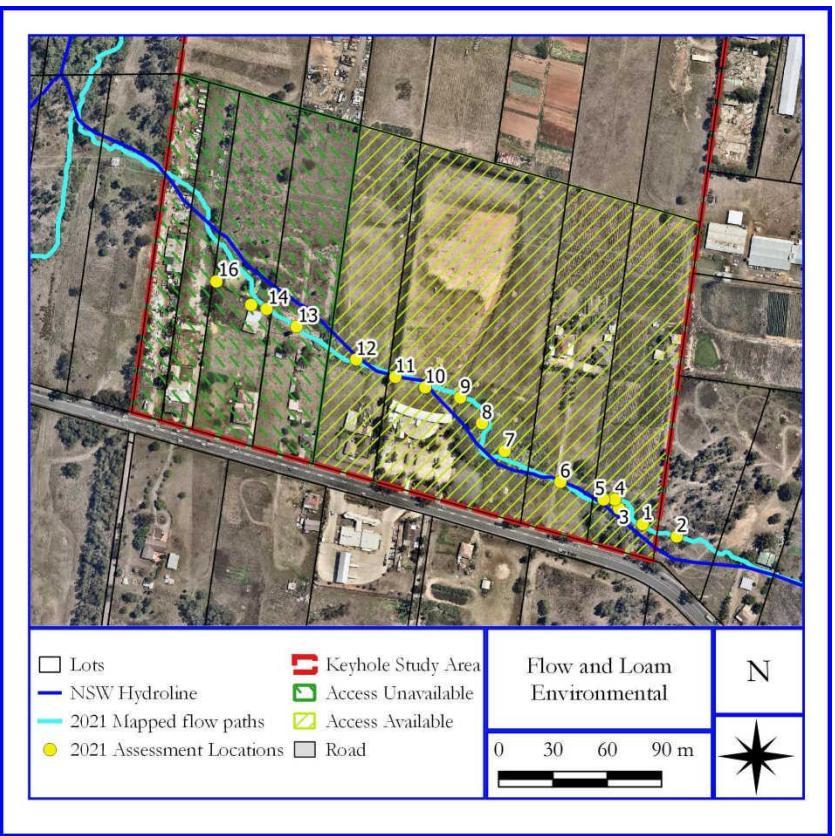
Figure 10. Study Area 3

Desktop review and analysis of the aerial photography reveal a channel with remarkable little variation of character and morphology. Channel sinuosity was measured from the confluence with Eastern Creek to the maximum upstream extent of the mapped channels. The sinuosity of the Hydroline is 1.04 over a channel length of 1125.3 m. The sinuosity of the 2021 mapped channel 1.11 over a channel length of 962.3 m. Both sinuosities are very low and are indicative of a highly modified channel.

Aerial photograph interpretation reveals what appears to be partially artificial channel and partly intact channel, especially in the upper reaches.
